TECHNICAL SERVICE BULLETIN

Malfunction Indicator Lamp (MIL) illuminated (DTC P049B)

21-2135

27 April 2021

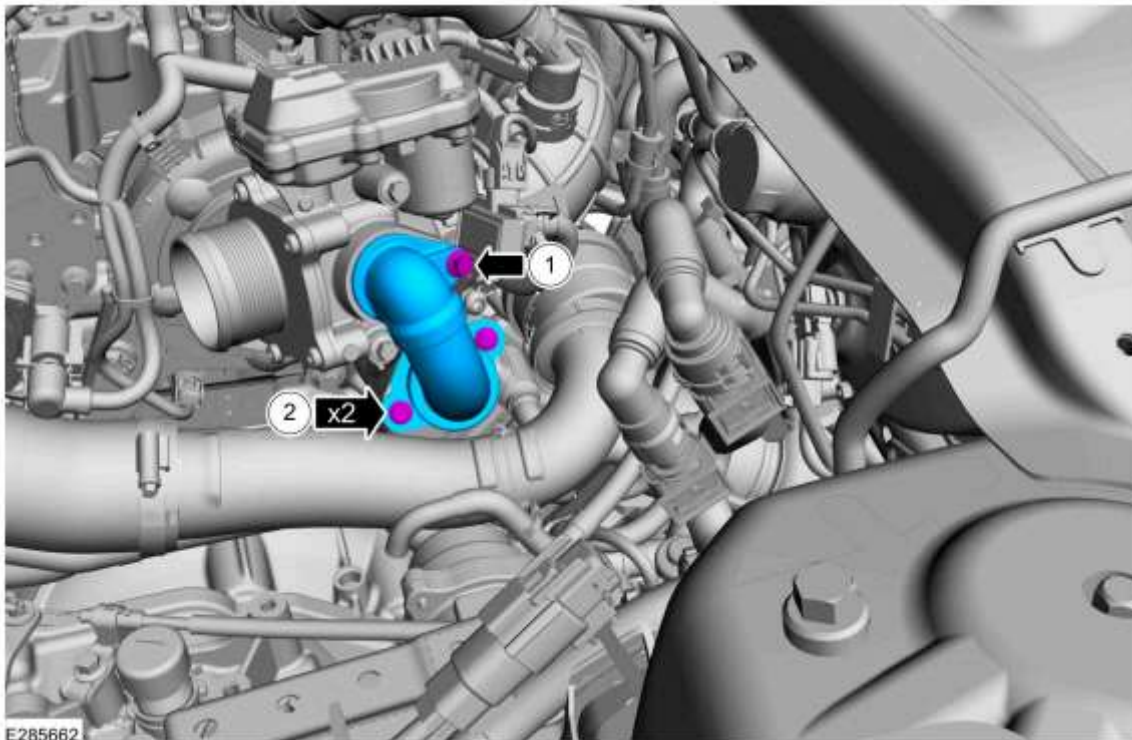
Remove the Exhaust Gas Recirculation (EGR) cooler to EGR valve tube. For additional information, refer to the corresponding Workshop Manual Section 303-08.
