TECHNICAL SERVICE BULLETIN

Charging system warning message plus battery symbol in instrument cluster with Diagnostic Trouble Code (DTC) P0562-00

24-2072

15 March
2024

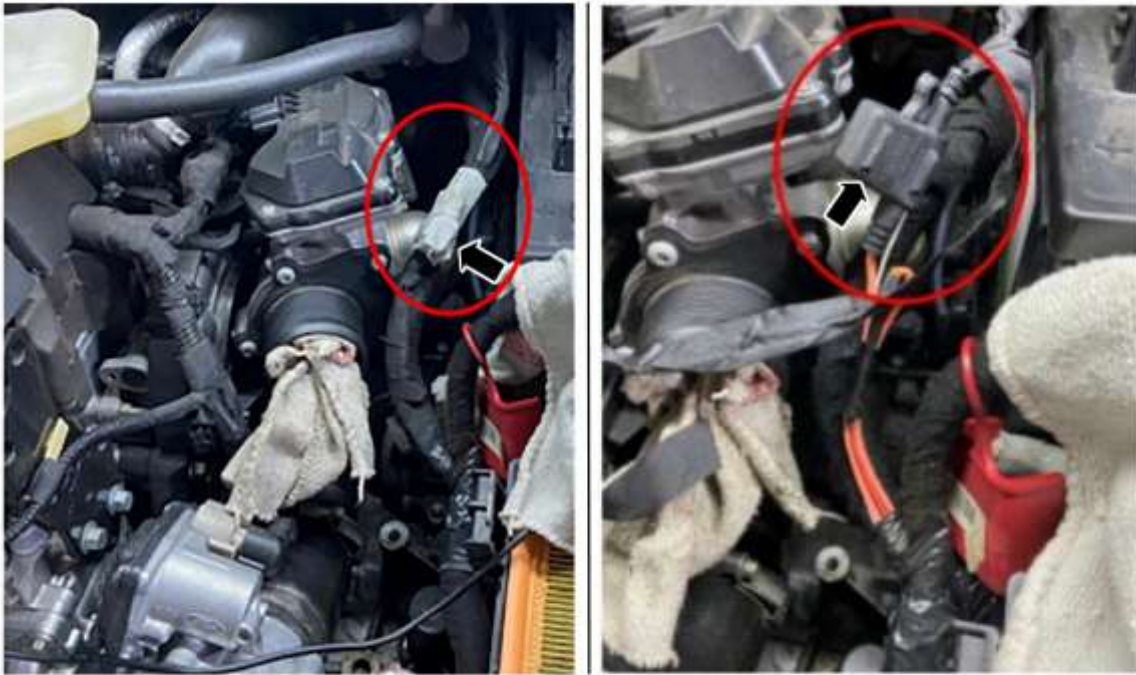
E429149

4. Locate the fuse in the wiring harness SBF09 to the Battery Monitor Sensor (BMS) in the near of electrical connector **C1647** Pin 2 (under the silver insulating tape) which is not in the wiring schematic located between the EGR valve and the battery plus pole (refer also to the following **updated** wiring schematic for details).

- Carefully remove the isolation from the wiring harness branch to the BMS electrical connector.

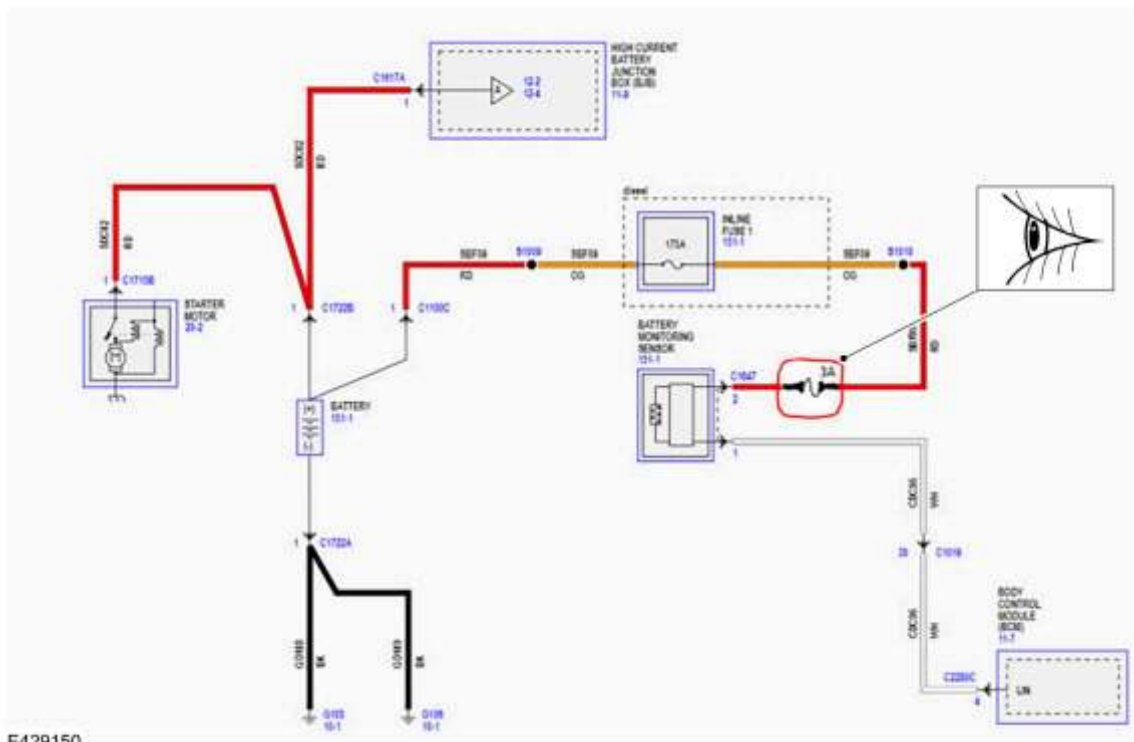
E429150

5. Updated wiring schematic for information.
