## GENERAL SERVICE BULLETIN

### Malfunction Indicator Lamp (MIL) illuminated on the instrument cluster in conjunction with loss of power, poor idle or hesitation

**24-7026**

21 March  
2024

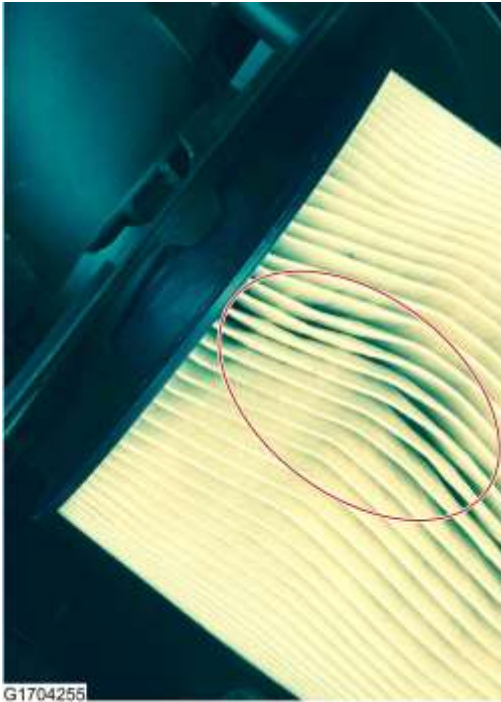
A damaged or distorted air cleaner element changes air flow to the TMAF-Sensor

1. Inspect air cleaner element for debris, leaves, plastic casting flashing, ensure there are no blockages in the inlet or outlet.

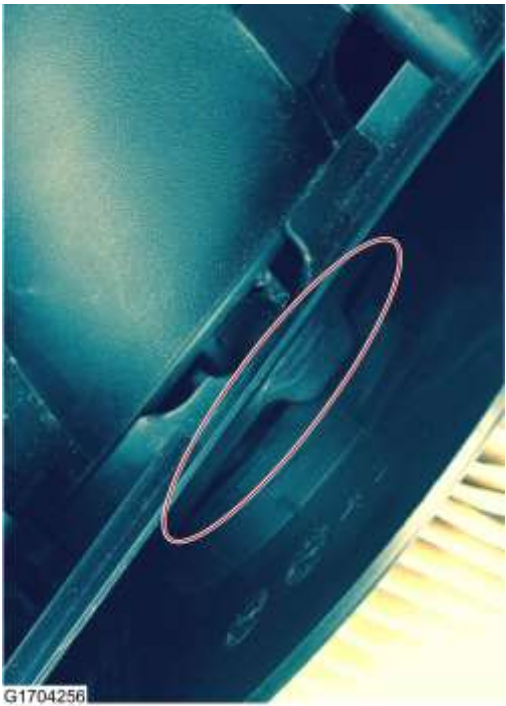
Air cleaner element misfitted
