TECHNICAL SERVICE BULLETIN

2017-2019 Fusion/Mondeo- 2.0L EcoBoost - Rattle Noise At The Transmission Bellhousing Area

23-2198

12 July 2023

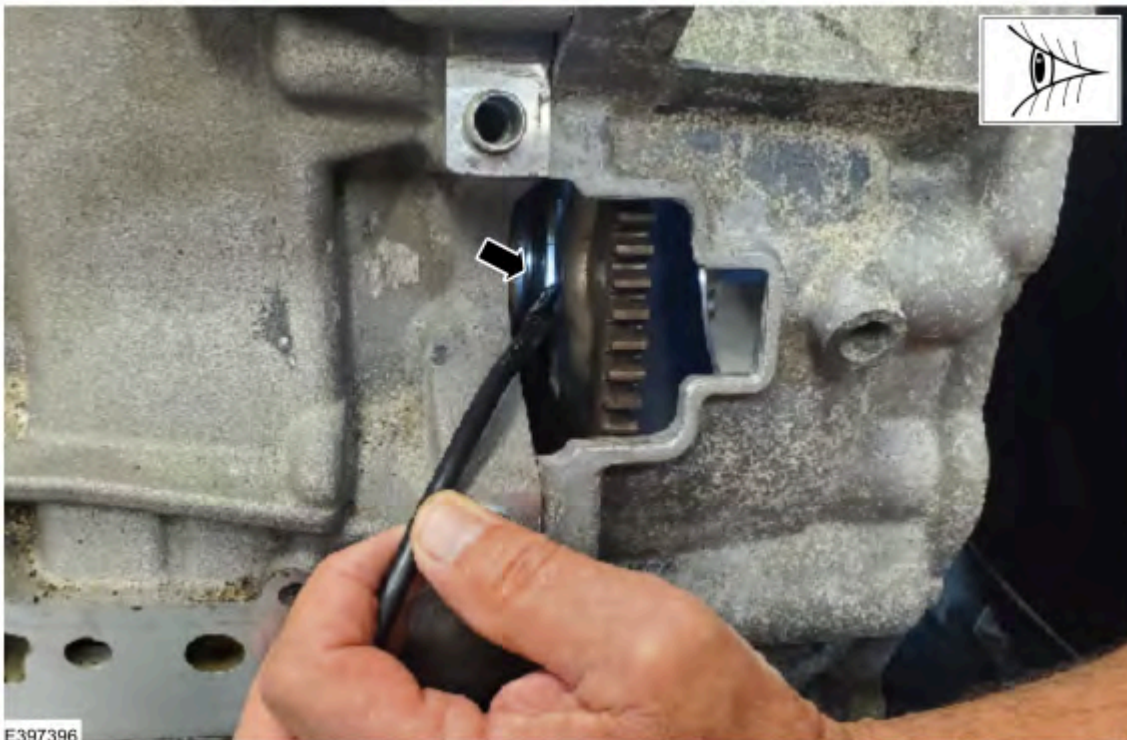
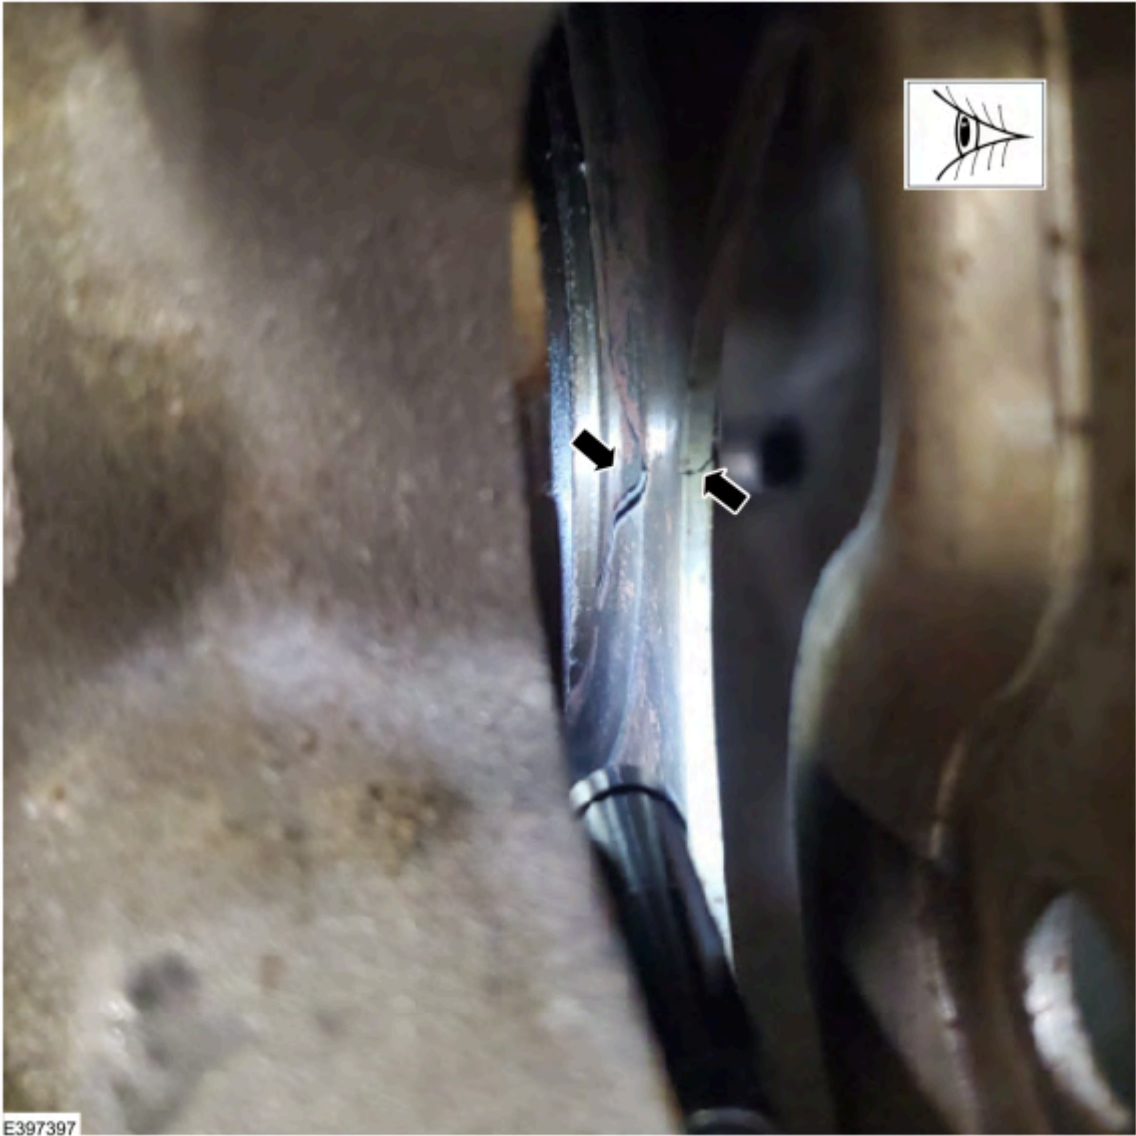
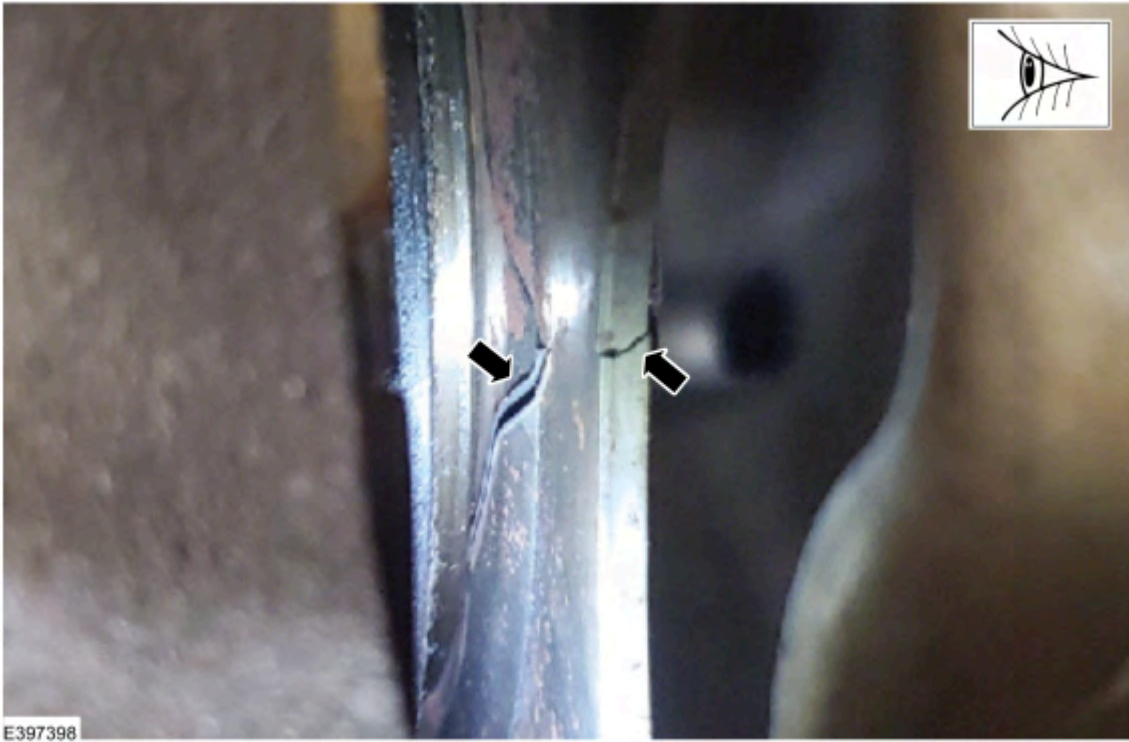
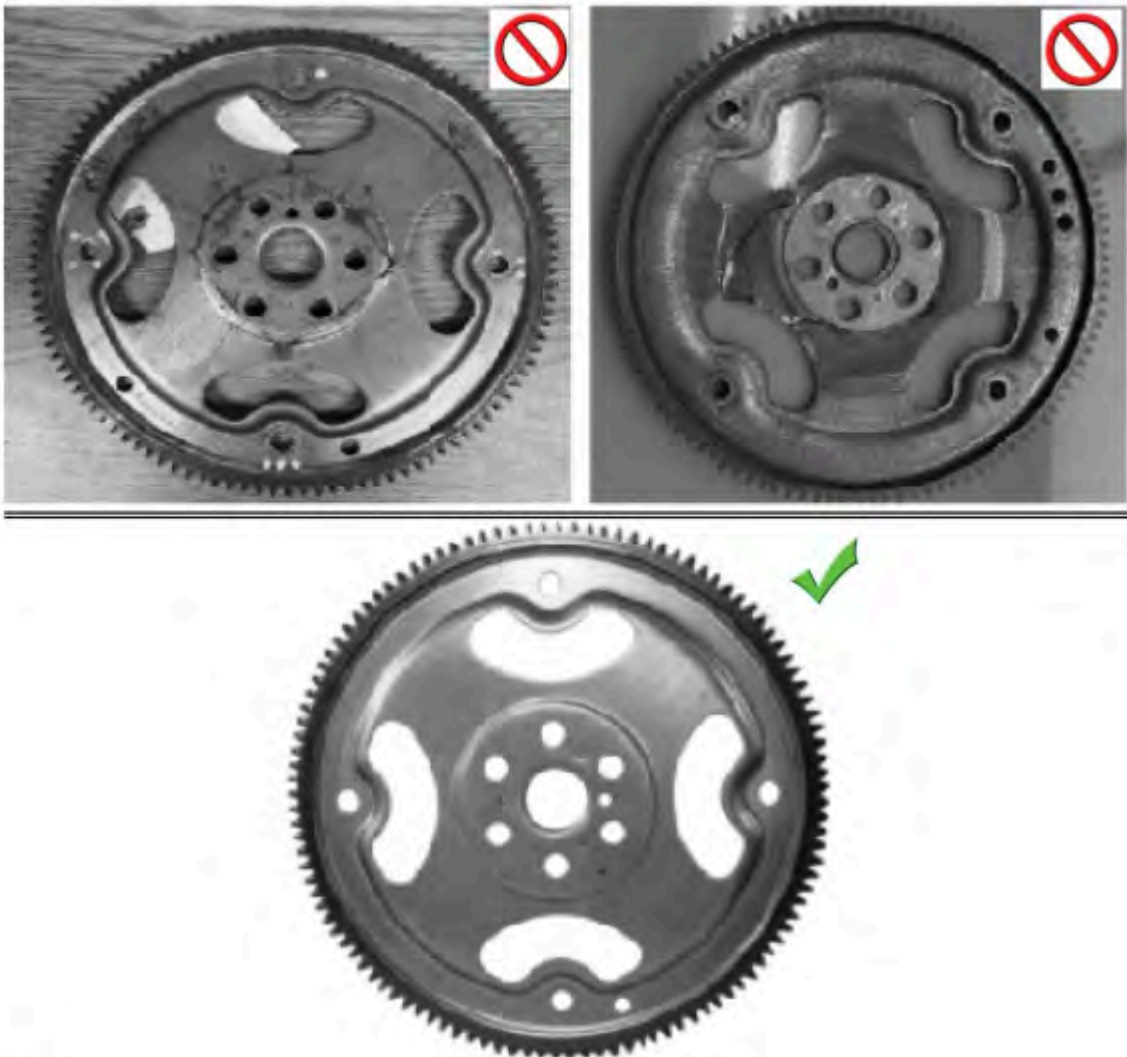
4. Placing a borescope between the engine block and flexplate, inspect the flexplate for cracks near the crankshaft. Are there any cracks present in the flexplate? (Figures 1-4)

NOTE: It may be necessary to rotate the engine crank to find the cracks in the flexplate.

- (1). Yes - proceed to Step 5.
- (2). No - reinstall the starter motor. Refer to WSM, Section 303-06. For further diagnostics outside this article, refer to WSM, Section 100-04. Repair is complete.

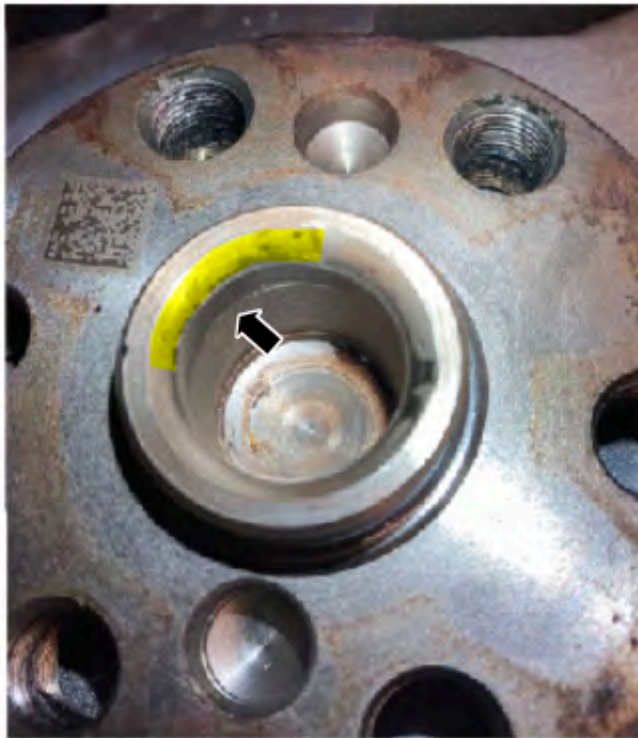
Figure 5

- 15.** Inspect for damage on the crankshaft pilot bore. Is there damage? (Figure 5)

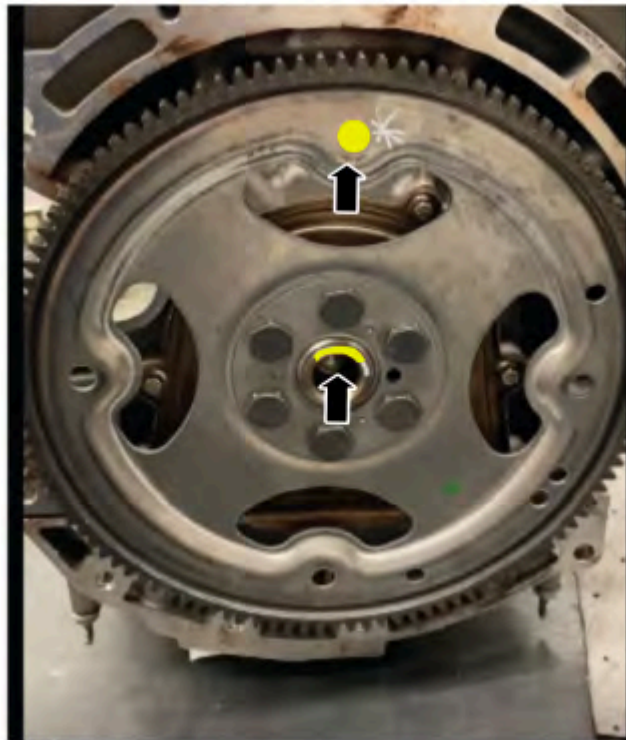
Figure 6

(1). Yes - rotate the stud hole nearest to the 12 O'clock upright position so that the damaged part of the crankshaft pilot bore is at the 12 O'clock position. This is important to endure minimal imbalance. Proceed to Step 16. (Figure 6).

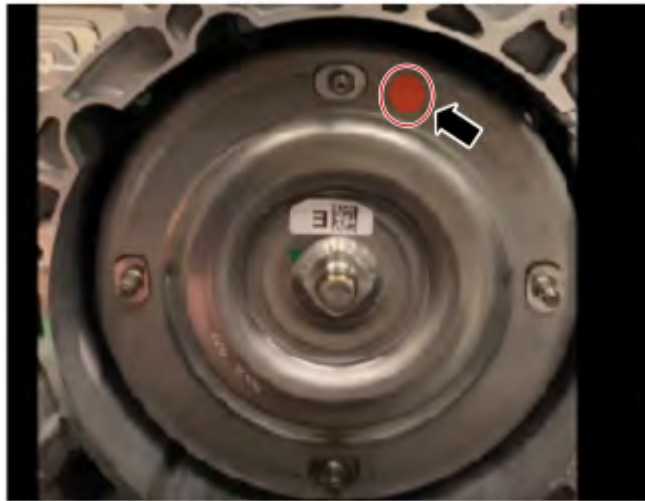
Figure 7

16. Locate the balance mark on the torque converter and rotate the stud nearest to the 12 O'clock position. (Figure 7)

(1). The balance mark indicates the heavy side of the torque converter.

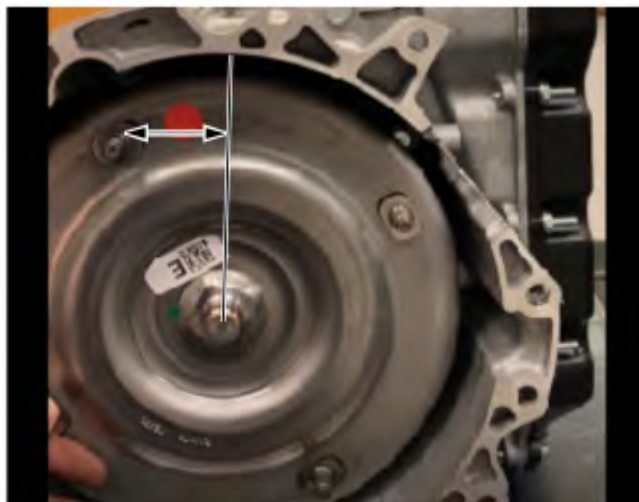
Figure 8

(1). When tightening the torque converter nuts, rotate the nearest stud the minimal amount to the window and install nut. (Figure 8).
